# **MICROSILICA 600**

**INDUSTRIAL & COMMERCIAL FLOORS**

A natural Pozzolan for high  
performance concrete

### for Industrial & Commercial Floors

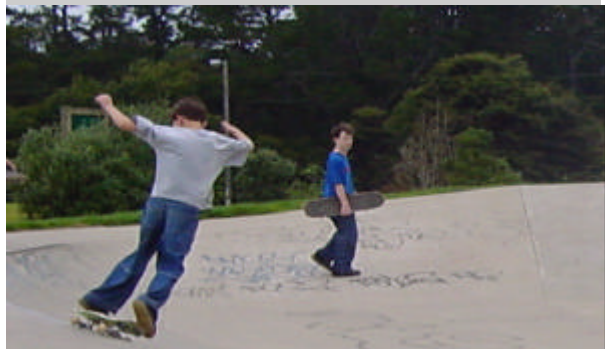
**Figure 1.** Microsilica 600 was used for the Titirangi Skate Park for ease of placing and superior abrasion resistance.

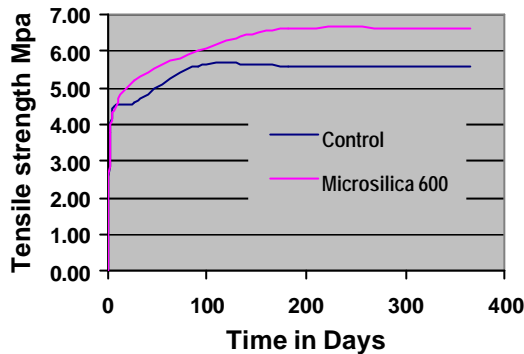
**Tensile Strength (Opus 1999)**

**Figures 2.** The strength of MS600 (8% MS600, W/CB - 0.40) continues to grow over time.

The addition of **Microsilica 600** increases the cement matrix strength and the aggregate bond at the cement paste interface.

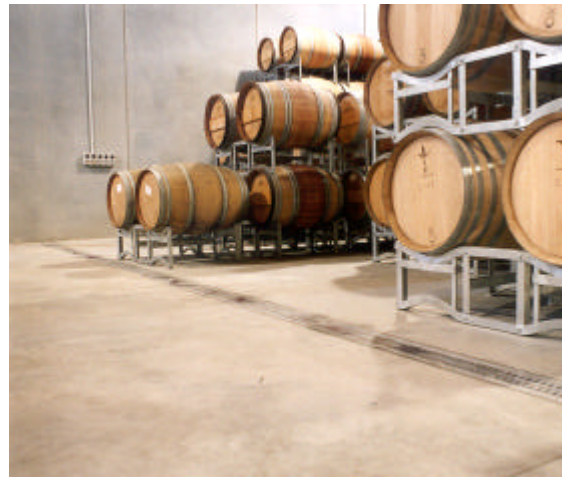
**Figure 3.** Wine is mildly aggressive to concrete. Extended service life and improved hygiene can be achieved with the use of Microsilica 600.

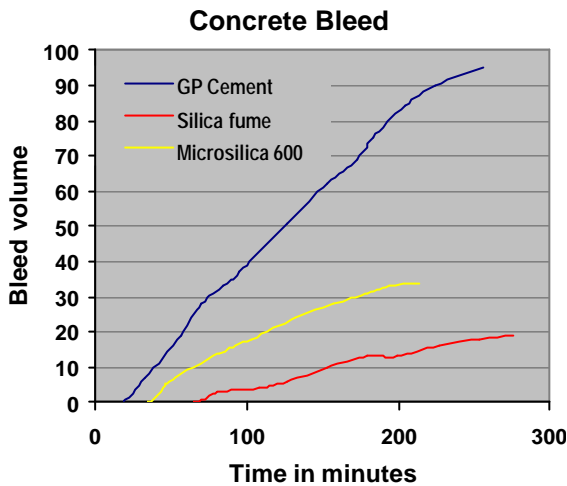
**Figure 4.** Conventional concrete has high bleed and potential problems with plastic settlement, a low performance surface etc. Fine powders that virtually eliminate bleed lead to plastic cracking problems. **Microsilica 600** provides the optimum bleed.

The high bleed of conventional concrete can lead to plastic settlement cracking over reinforcing bars and a high water content/low durability surface. By contrast plastic shrinkage cracking in very low bleed concrete occurs when there is insufficient bleed water to replace water that is evaporating. **Microsilica 600** provides the optimum solution, concrete with high durability and strength but with just sufficient bleed to minimise the risk of plastic cracking.

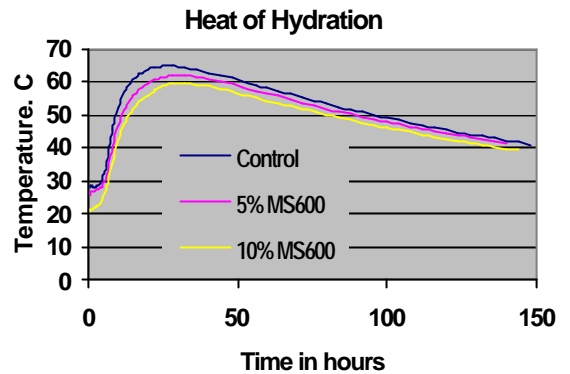
**Figure 5.** Temperature rise of concrete with constant binder content and w/b ratio show similar thermal properties for GP cement and **Microsilica 600** concrete.

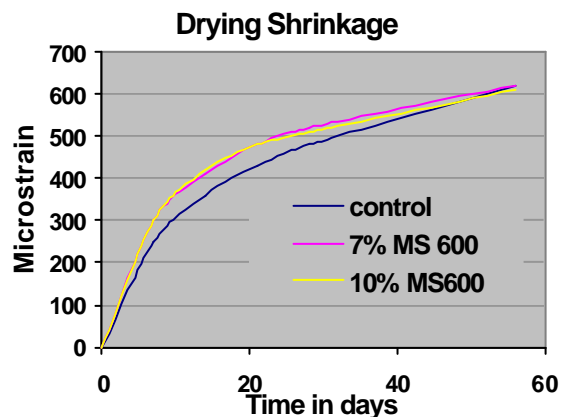
**Figure 6.** Shrinkage of **Microsilica 600** concrete is similar to conventional concrete.

At similar binder and water contents, **Microsilica 600** concrete has similar shrinkage properties (Figure 6). However **Microsilica 600** has a higher strength to resist the internal stresses and therefore the overall risk of shrinkage cracking is less. Standard crack control measures should be used.
